HAZARD MANAGEMENT BULLETIN

Stacking 1100kg Synthetic Material Super Sacks¹

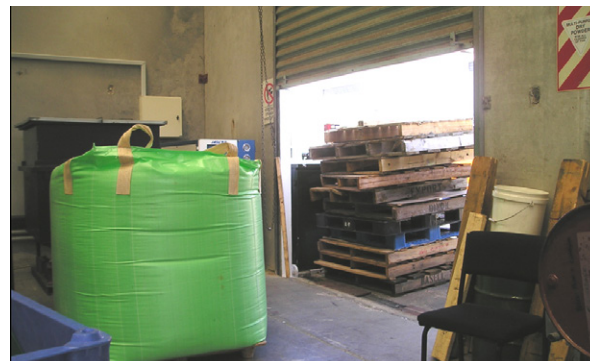
1

Picture 1: the size of the texPET sack can be viewed against the building's half-open garage door.

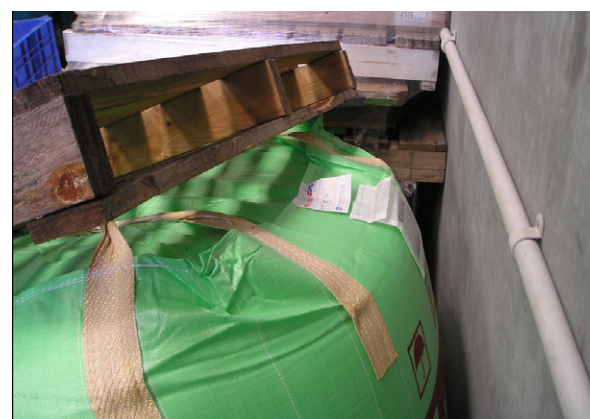
2

The investigation found that the highest super sack compressed, causing a change in its positioning and stability upon the middle super sack.

Picture 2: this photo displays the compression to a lower-stacked super sack from the bag that was previously stacked on top.

It is the Department's advice that synthetic type super sacks should be stored at ground level. Where there is a requirement for these sacks to be stacked vertically, precautions should be taken to prevent the sacks moving or settling by vibration.

The employer must take all practicable steps to identify this significant hazard and have in place an effective method to support and restrain the stacked super sacks.

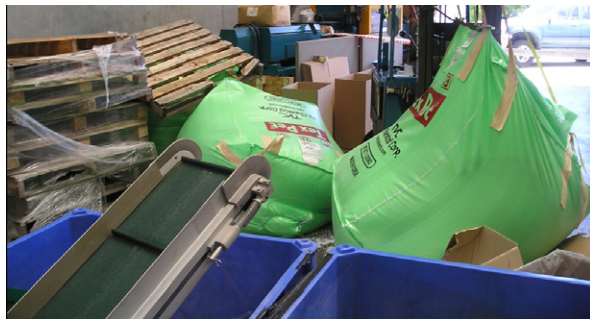
The operator had stacked three synthetic super sacks on top of each other against a supporting wall. No stabilisation was positioned between the top and middle sacks to support them.

Picture 3: this photo shows one super sack in the background stacked alongside the concrete wall (partially obscured by pallets and second super sack). Super sack 2 has fallen over, to land in front of super sack 1. Super sack 3 is the sack that crushed the worker. The bag's straps are hanging on the forklift's tines (the forklift was used to move the bag off the worker).
